Application Note

IR reflection troubleshooting

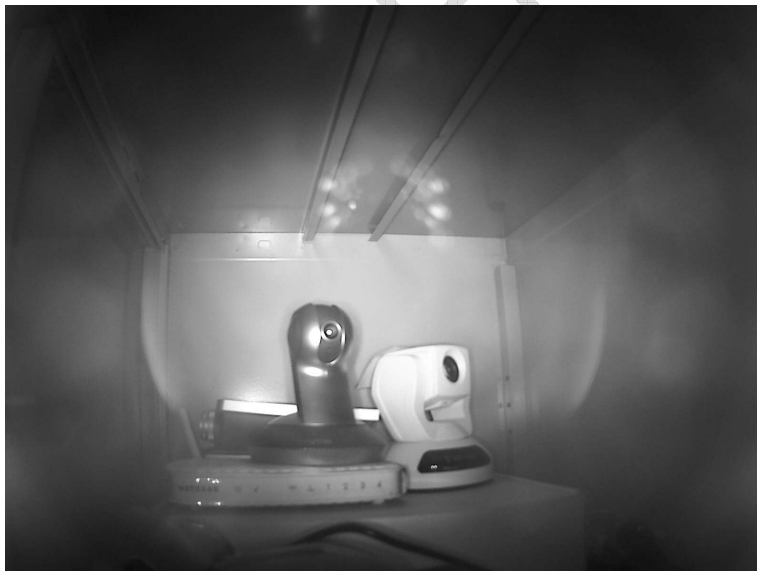
When adjusting the focus and angle of the lens on a camera equipped with IR LED, you may find image quality is poor in night mode. This is almost always due to IR reflection causing a clouded effect. Please refer to the two pictures below if you are having an issue with image quality to check if it is due to IR reflection.

Video affected by IR reflection

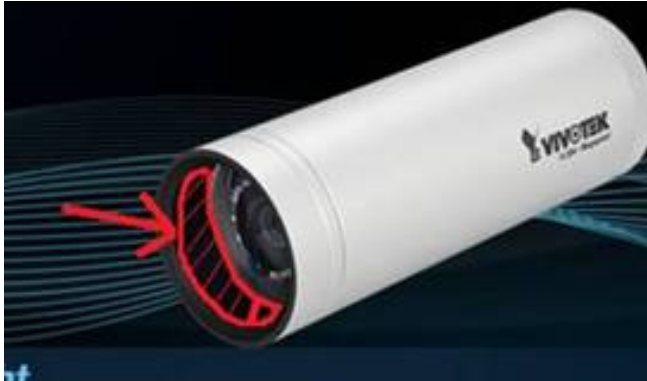
1.1 Is there any dust on the sun shield ring? (IP8332)

Accumulated dust will reflect infrared, causing a blur ring in the image. Refer to the photo below, and see section 2.3 for instructions on how to fix the problem.

2.3 Clean the cover

- a. Use compressed air to remove dust or other debris

- b. Use an air gun with air compressor to remove dust or other debris

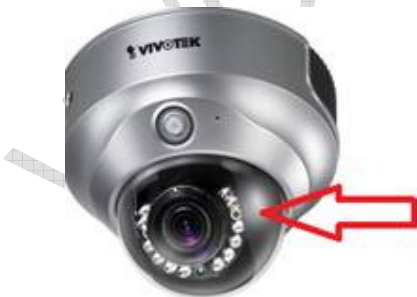
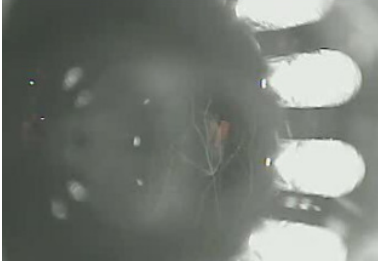
1.2 Is the black mask in the right position, or is it blocking the IR LED? (FD8134/FD8161/FD8162F/D8135H/FD8335H)

If the black mask is positioned incorrectly, it will reflect infrared, causing image blurring. See section 2.8 for instructions on how to fix the problem.

2.8 Adjust the black masks to the correct position

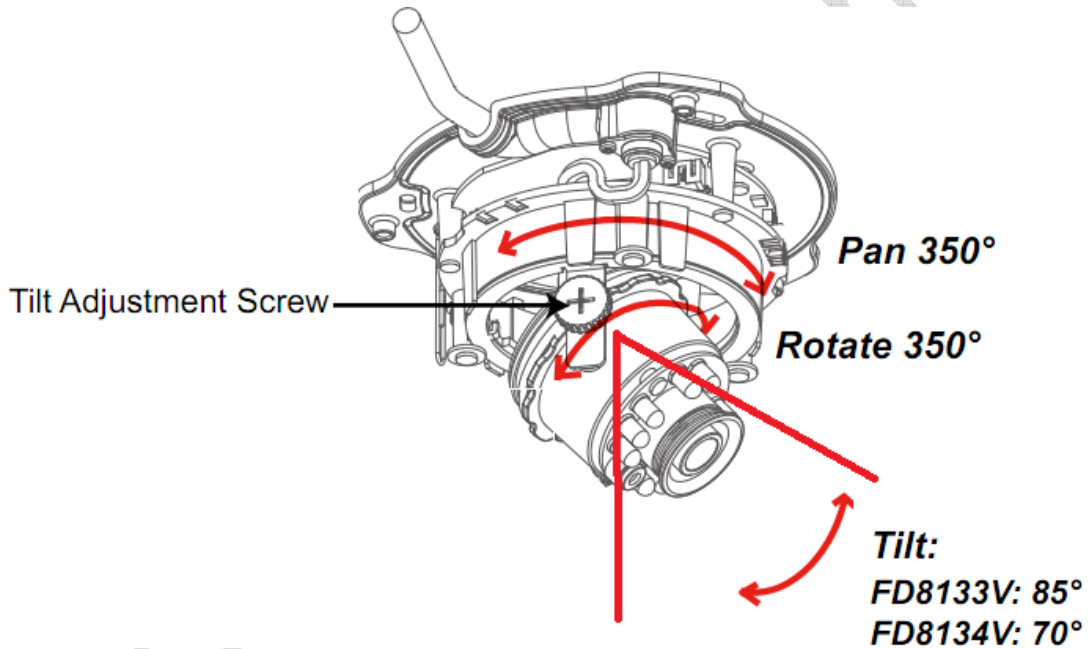
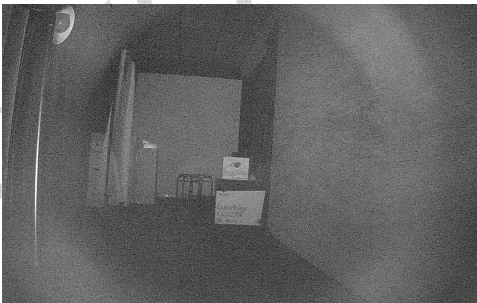
1.3 Is the lens tilted at an angle between 0° and 70°? (FD8134V)

If the tilt is outside this range, the rubber ring cannot create a seal with the cover. See section 2.9 for instructions on how to fix the problem.

2.9 Use the tilt adjustment screw to adjust the tilt angle so that it is between 0° and 70°.

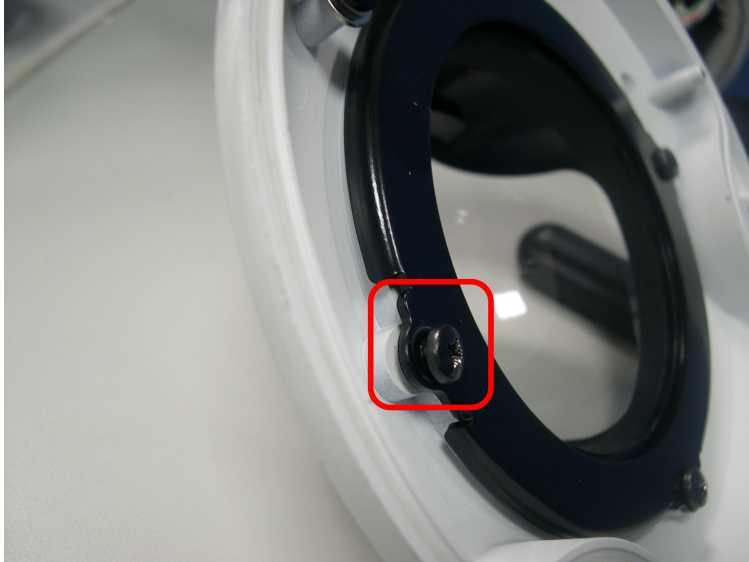
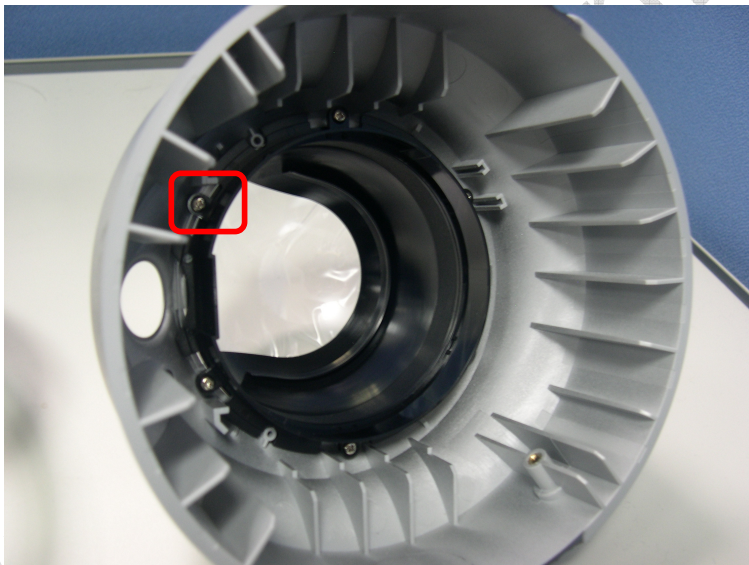
1.4 Is the cover improperly fitted to the body of the camera?

The cover of the camera may not be properly secured to the body. Refer to the photos below, and see section 2.1 for instructions on how to fix the problem.

2.1 Tighten the screws securing the cover to the body of the camera .

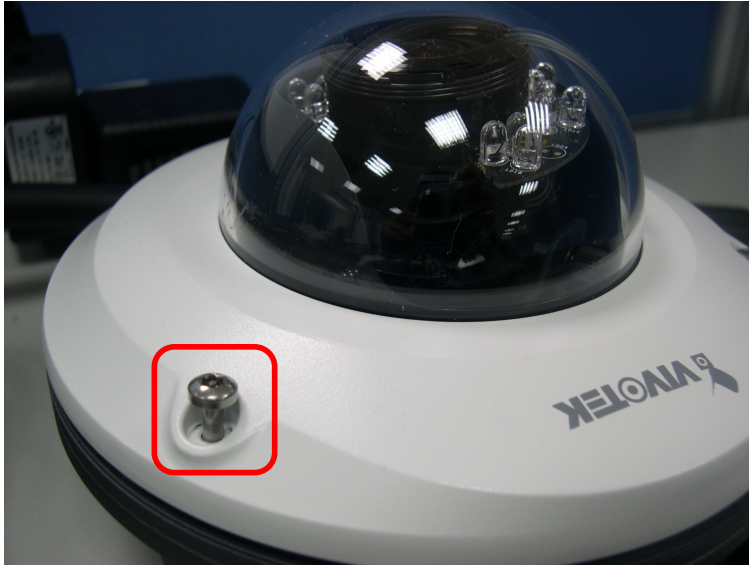
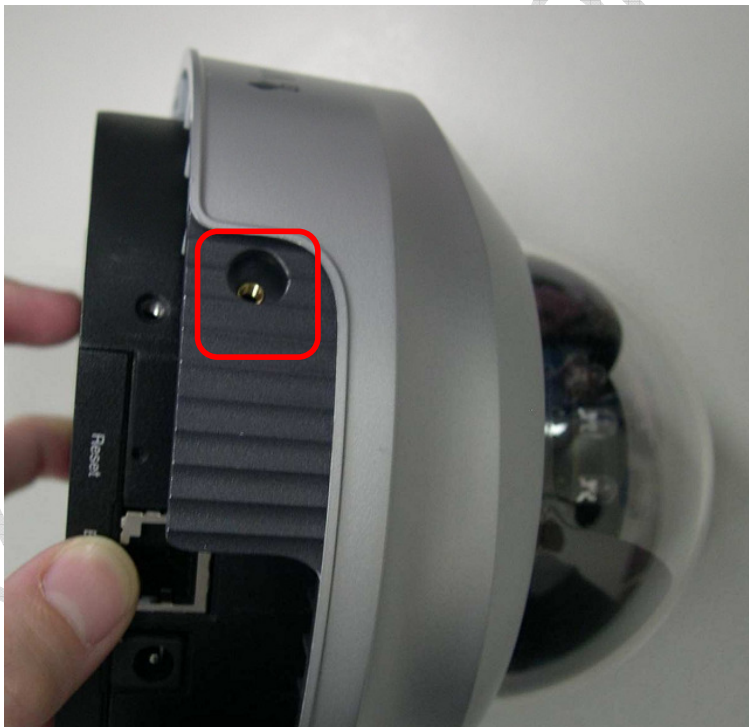
1.5 Are the screws securing the cover to the body of the camera loose?

The screws used to attach the cover of the camera to the body may have loosened. Refer to the photos below, and see section 2.2 for instructions on how to fix the problem.

2.2 Tighten the screws on the camera body

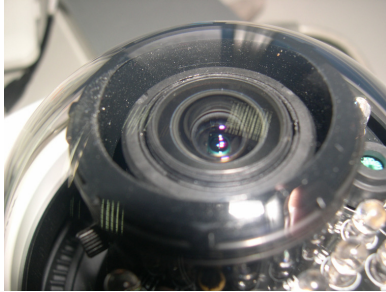
A dirty or scratched cover may adversely affect image quality. Refer to the photos below, and see section 2.3 for instructions on how to fix the problem.

A dirty cover

NOTE: Do not use clothing to clean the dome cover, as scratching may result. If the cover is scratched, please contact your vendor for a replacement.

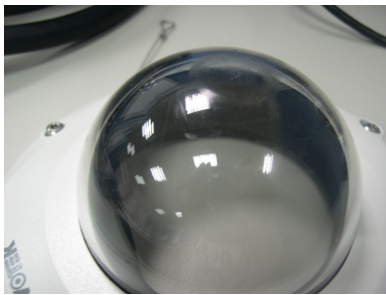
A scratched cover

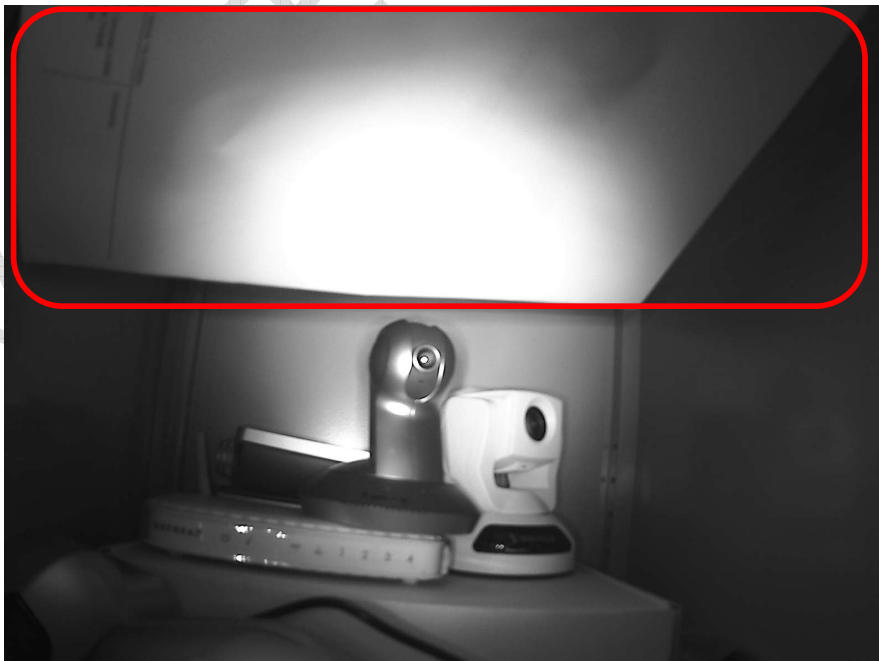
1.8 Is the camera directly underneath a surface such as a ceiling?

The surface may be reflecting IR light and thus adversely affecting image quality. Refer to the photo below, and see section 2.5 for instructions on how to fix the problem.

- 2.5 Covering the overhanging surface with a non-reflective material may help. Otherwise, the camera may need to be moved to another location.

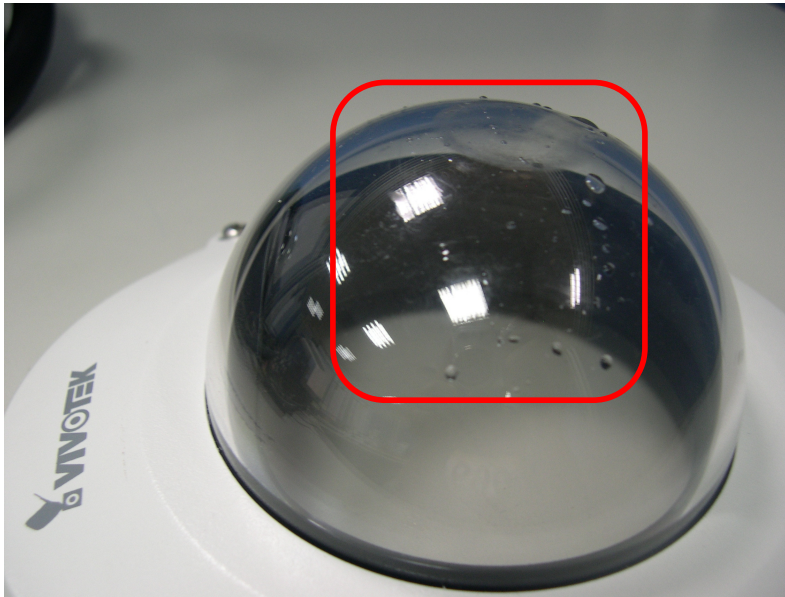
Any fogging or water droplets may adversely affect image quality. Refer to the photos below, and see section 2.6 for instructions on how to fix the problem.

Condensation on the cover.

- 2.6 Clear off any condensation on the inside or outside surface of the cover, and place a packet of silica gel desiccant inside the camera to absorb humidity

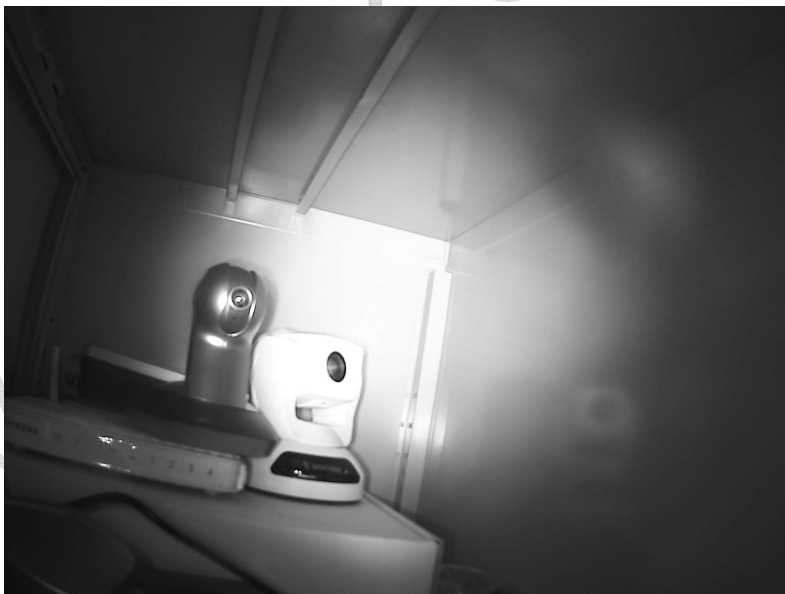
IR reflection caused by fogging of the cover

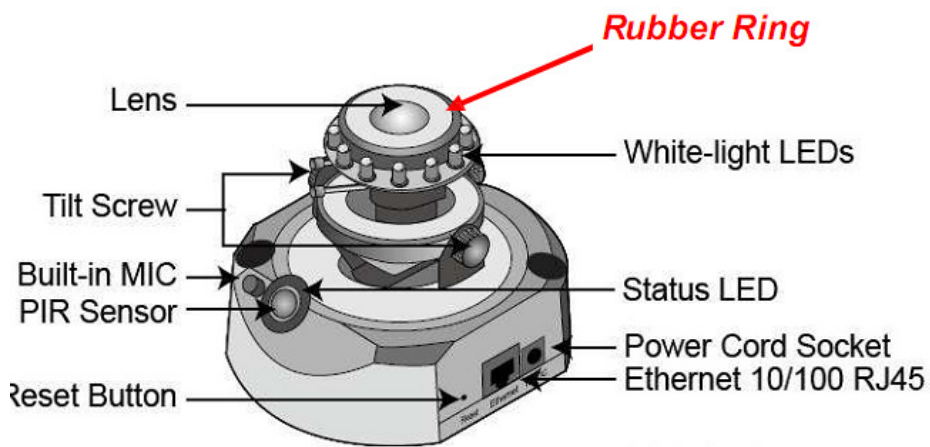
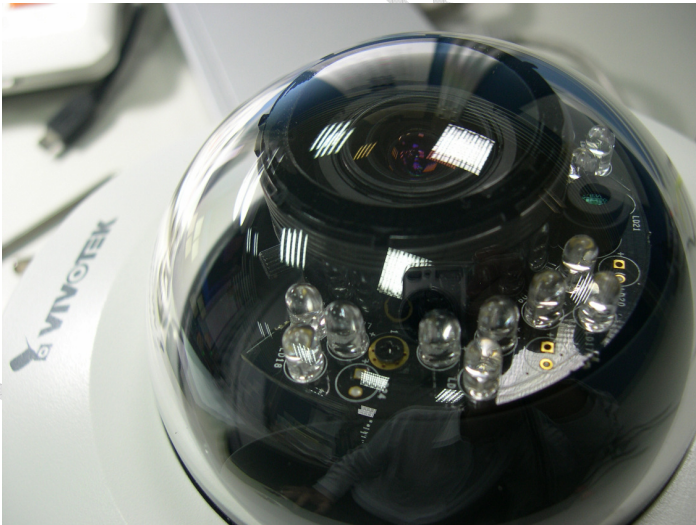
1.10 Is the rubber ring around the lens flush against the inside surface of the cover?

A rubber ring is used to seal the area of the cover directly in front of the lens from light emanating from the LEDs surrounding the lens. The seal may be lost after a user adjusts a variable-focus lens

If this rubber ring is not flush against the inside cover surface, light may leak in and cause IR reflection. If it is flush against the cover, the ring will be slightly compressed due to pressure. Refer to the following figures, and see section 2.7 for instructions on how to fix the problem

2.7 Re-fit the rubber ring

If the problem persists, use a new rubber ring. If you do not have a new one available, contact your vendor for a replacement rubber ring.
