Case study 1

The Sri Lankan Pumpkin Tank

Pumpkin (Wataka) Tank Construction details

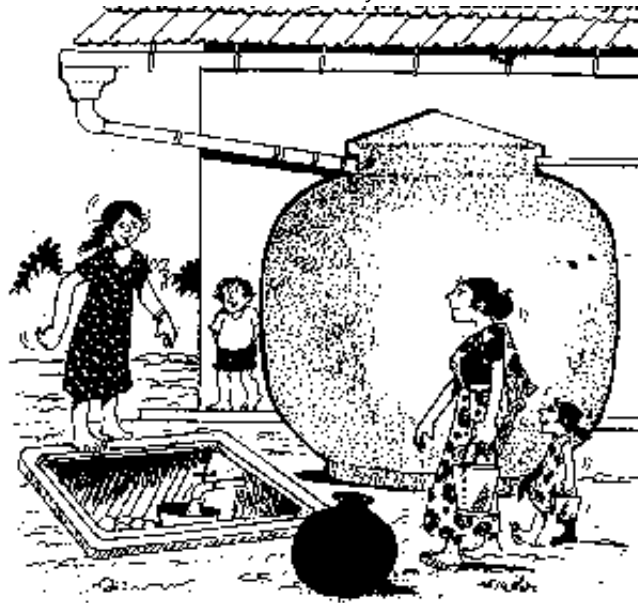
The Abikon family of Demetaralhina in Badulla District chose a pumpkin tank. Their village is in a rural highlands area of the country and the ground conditions were not suitable for a groundwater supply or for digging a pit for a below ground tank. Average annual rainfall is 2250mm with a bimodal rainfall pattern and a dry period, usually between December and April. Their per capita consumption was well below the 20 litres per day that each family member now consumes. The water is used for drinking (but only after boiling), cooking, personal and clothes washing. Mr Abikon also uses the water from their tank to water their 4 cows. Only towards the end of the dry season does the tank sometimes dry and then the family has to walk to the spring, about a mile from their home.

This pumpkin tank was built 3 years ago and is in very good condition. The construction is of ferrocement. The construction detail is given later. The cost of the tank is approximately SLR5,000 or Sterling 77.00. The materials and specialist labour for the tank were provided by CWSSP and the guttering was purchased by the Abikon family.
