Application Note

IR reflection troubleshooting

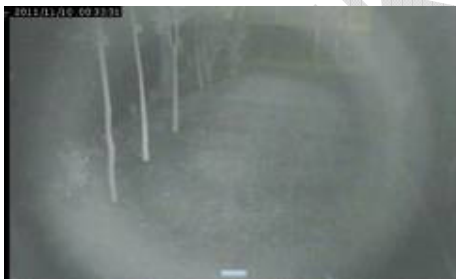
Reflection

A dirty or scratched cover may adversely affect image quality. Refer to the photos below, and see section 2.3 for instructions on how to fix the problem.

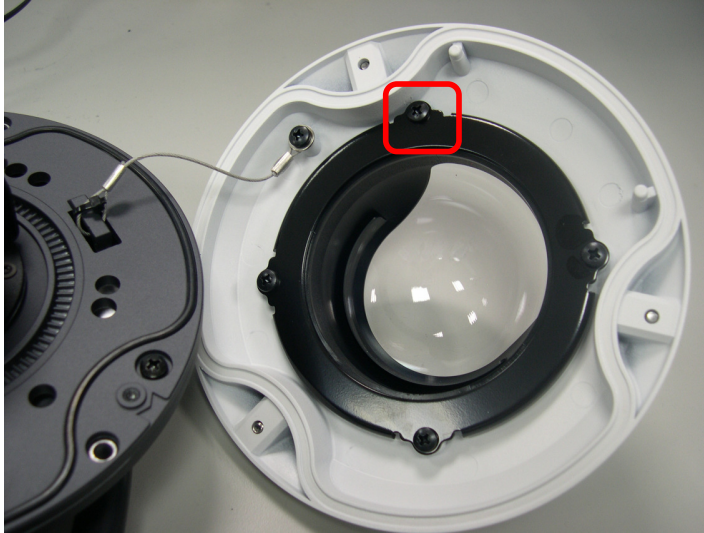
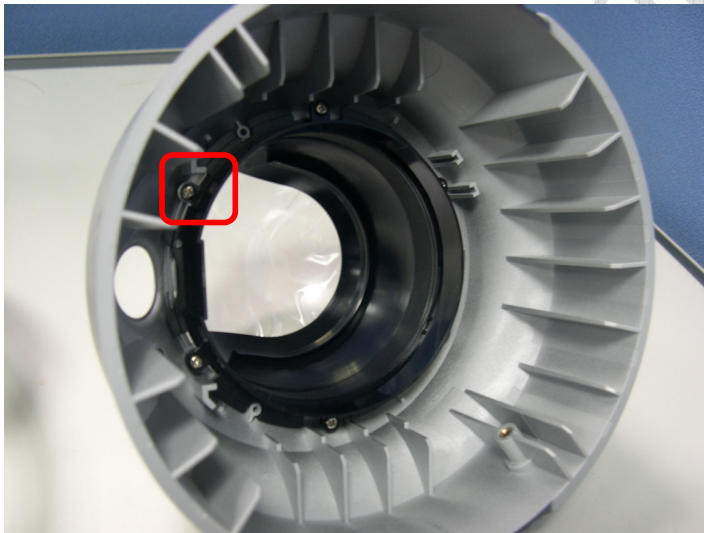
2.1 Tighten the screws securing the cover to the body of the camera .

The screws used to attach the cover of the camera to the body may have loosened. Refer to the photos below, and see section 2.2 for instructions on how to fix the problem.

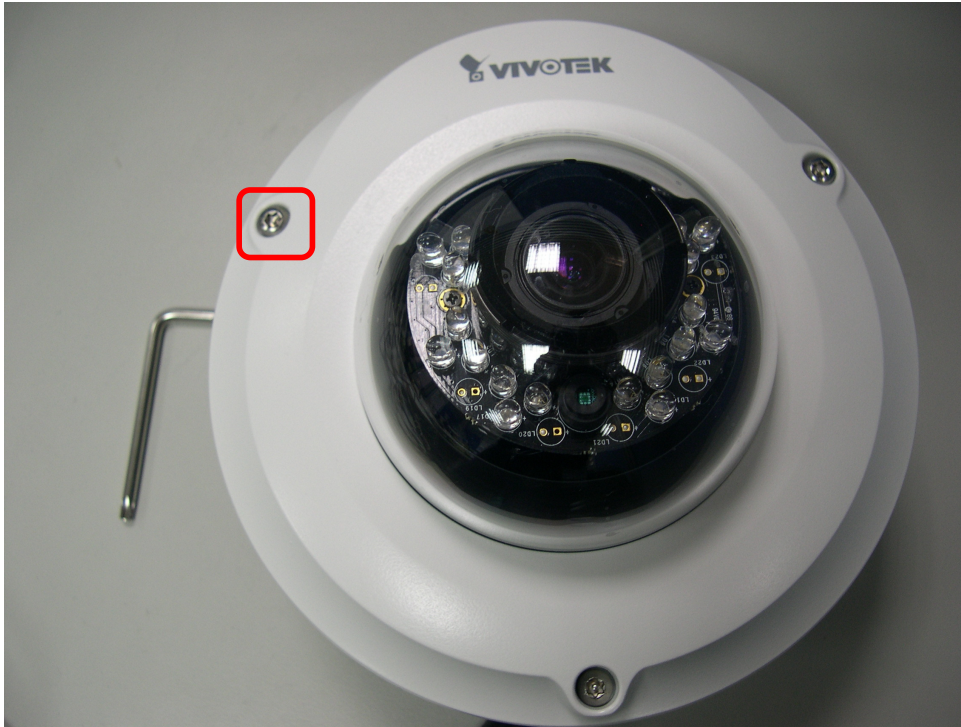
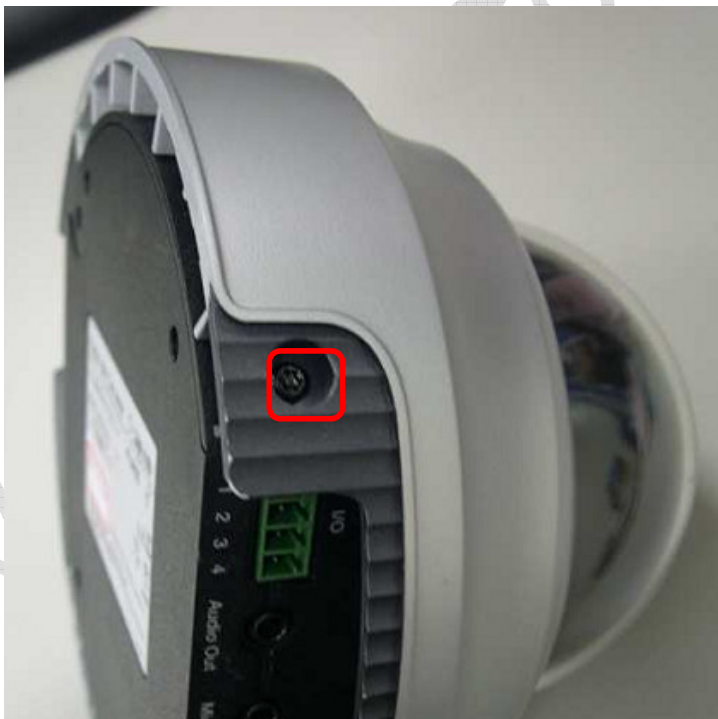
2.2 Tighten the screws on the camera body

The cover of the camera may not be properly secured to the body. Refer to the photos below, and see section 2.1 for instructions on how to fix the problem.

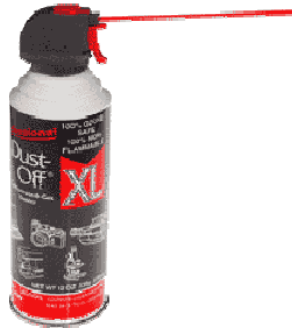
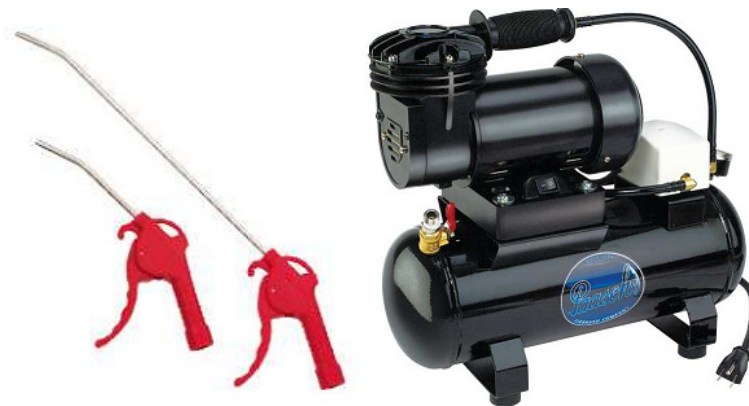
2.3 Clean the cover

Accumulated dust will reflect infrared, causing a blur ring in the image. Refer to the photo below, and see section 2.3 for instructions on how to fix the problem.

- a. Use compressed air to remove dust or other debris

- b. Use an air gun with air compressor to remove dust or other debris

NOTE: Do not use clothing to clean the dome cover, as scratching may result. If the cover is scratched, please contact your vendor for a replacement.

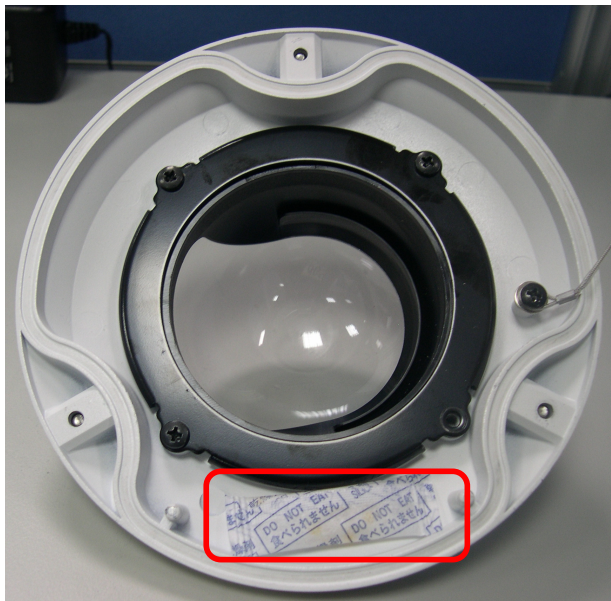
Any fogging or water droplets may adversely affect image quality. Refer to the photos below, and see section 2.6 for instructions on how to fix the problem.

- 2.6 Clear off any condensation on the inside or outside surface of the cover, and place a packet of silica gel desiccant inside the camera to absorb humidity

Use double-sided adhesive tape to attach the desiccant packet to the inside of the camera

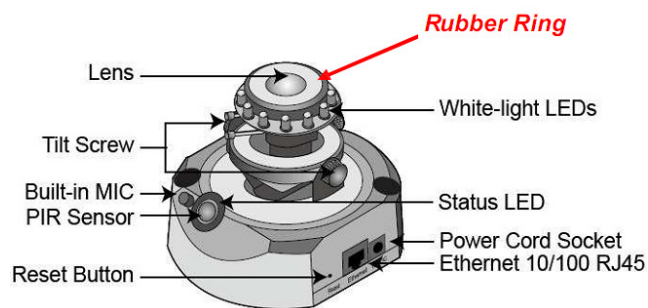
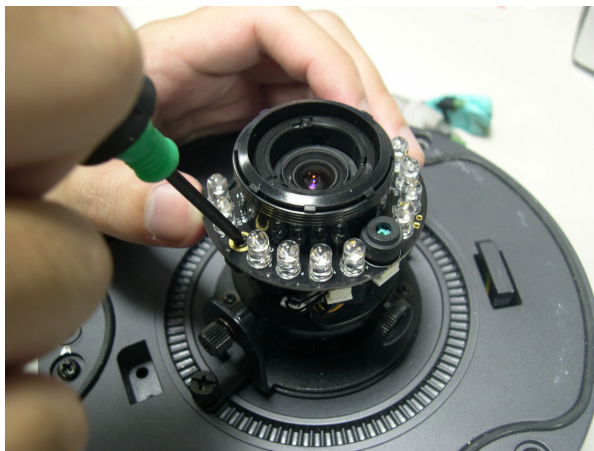
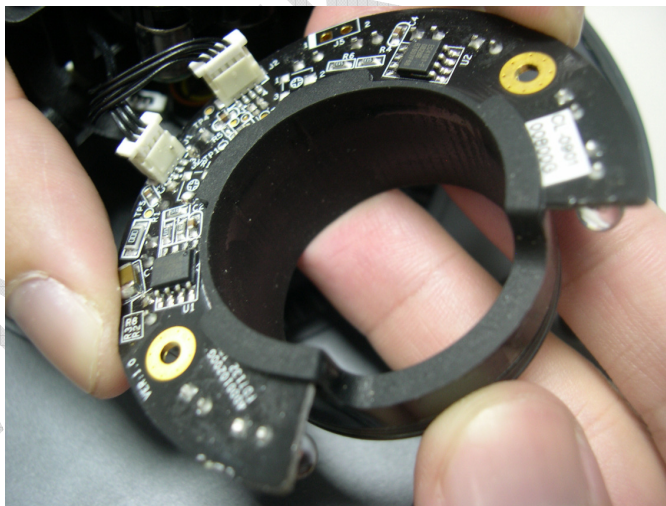
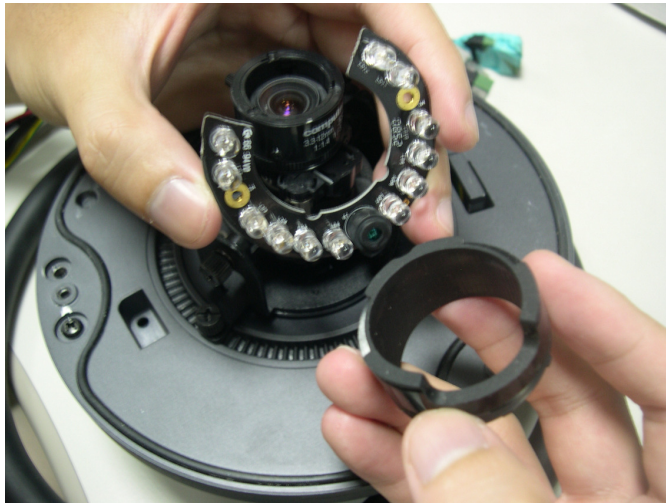
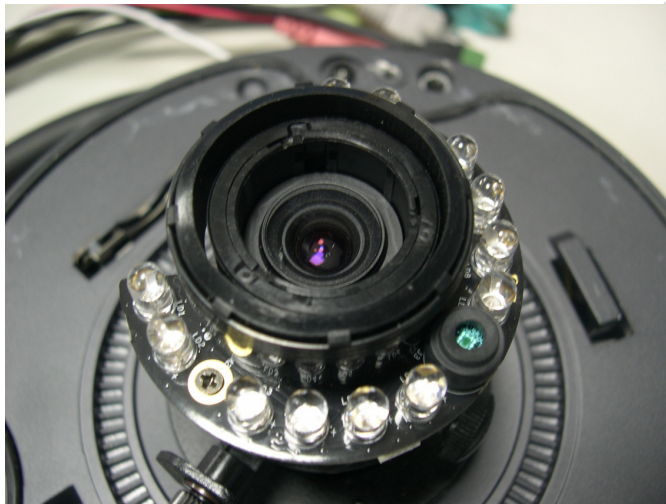
2.7 Re-fit the rubber ring

A rubber ring is used to seal the area of the cover directly in front of the lens from light emanating from the LEDs surrounding the lens. The seal may be lost after a user adjusts a variable-focus lens

If this rubber ring is not flush against the inside cover surface, light may leak in and cause IR reflection. If it is flush against the cover, the ring will be slightly compressed due to pressure. Refer to the following figures, and see section 2.7 for instructions on how to fix the problem

Use the following steps to re-fit the rubber ring.

- Loosen the screws on the circular base on which the IR LEDs are mounted

- Carefully remove the rubber ring

- c. Fit the rubber ring to the circular base again

- d. Attach the base again with the screws

If the problem persists, use a new rubber ring. If you do not have a new one available, contact your vendor for a replacement rubber ring.

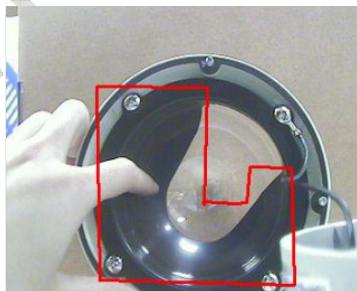
2.8 Adjust the black masks to the correct position

If the black mask is positioned incorrectly, it will reflect infrared, causing image blurring. See section 2.8 for instructions on how to fix the problem.

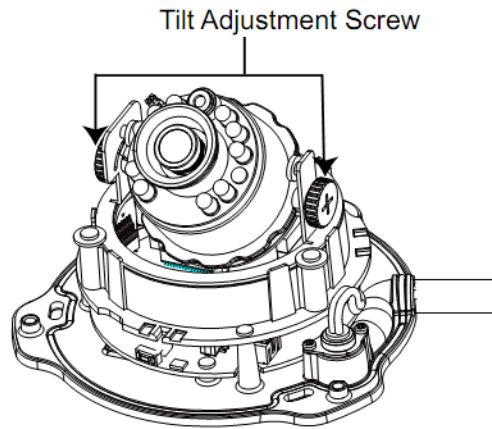
If the tilt is outside this range, the rubber ring cannot create a seal with the cover. See section 2.9 for instructions on how to fix the problem.

2.9 Use the tilt adjustment screw to adjust the tilt angle so that it is between 0° and 70°.
